Williston Federated Church Steeple Repair Project

This is a project supervised by
the
Trustees of the Williston
Federated Church

Jay Southgate Inspection Report Net

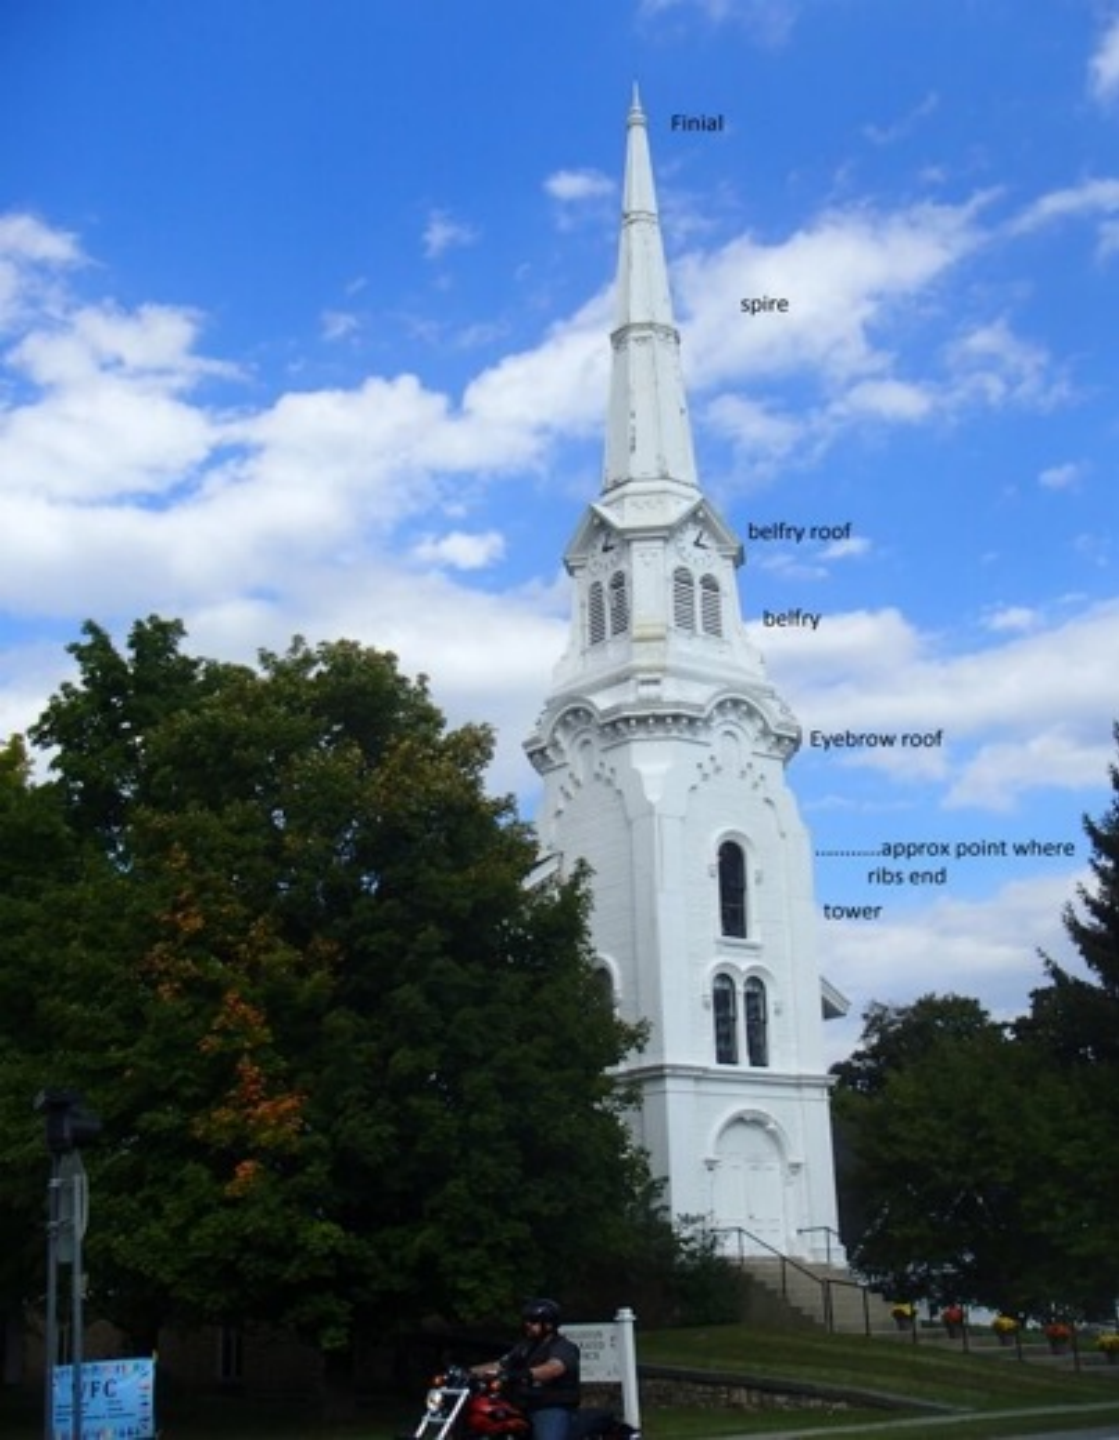
- As indicated in picture, structure of spire comes down to just above the main roof ridgeline/uppermost front window. Think of this structure as an upside-down octagonal ice creamcone with 8 full length structural ribs that define the corners. Jay Southgate refers this structure as the “cone”
- The ribs of the cone rest on transfer beams in the tower at the point indicated by in the picture that line on the front foto. So called because they transfer the load to the outer structure.
- This is a good and common method of steeple design.
